# Caleb Kinsaul Real Estate Services LLC. Your Property Inspection Report

2222 A Street, Columbus, GA 22222 Inspection prepared for: Sample Sample Real Estate Agent: Support - Home Inspector Pro

Date of Inspection: 9/6/2016 Time: 9:00 AM Age of Home: 24 Size: 3200 Weather: Clear SAMPLE

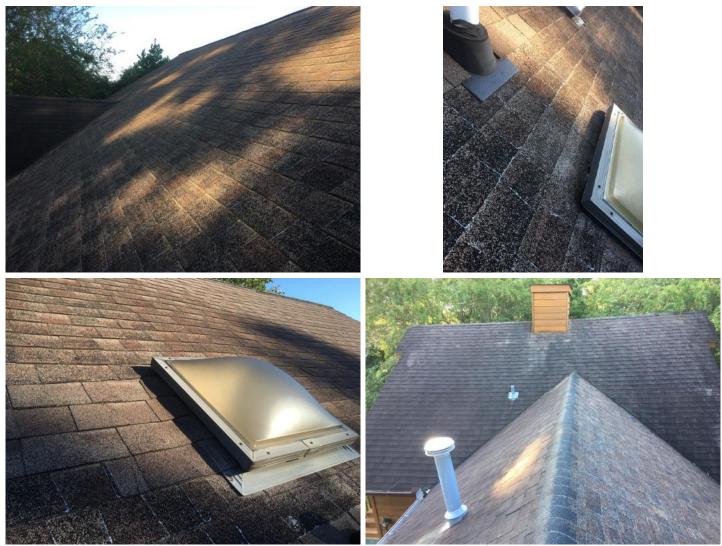
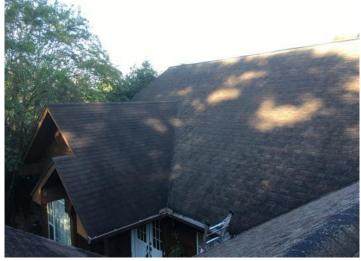
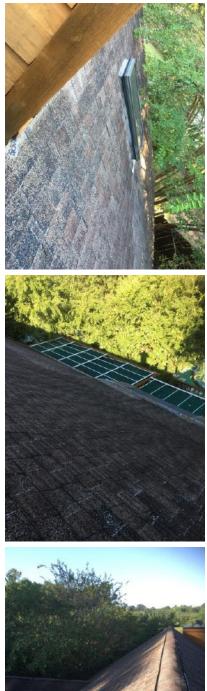
- Clean roof areas: Significant amounts of organic debris evident.
- Some shingles damaged.
- Some shingles curling.
- Maintenance Tip: Weather permitting, keep debris cleared from roof valleys to extend life of roof.
- Shingles are showing wear and may be nearing the end of their service life. Currently there appear to be no issues.

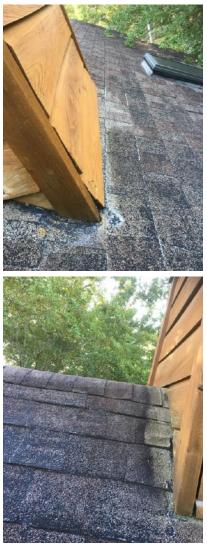
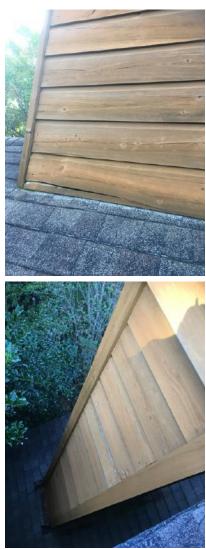
• Some wood on chimneys is cracking and or deteriorating. Monitor for future issues. Repair or replace damaged boards. See photos

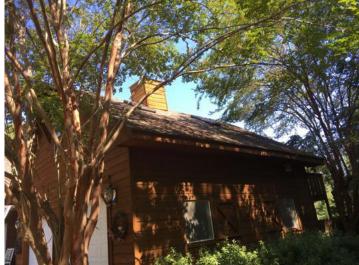
• Trim trees that are in contact or proximity to home, as branches can abrade roofing or siding.

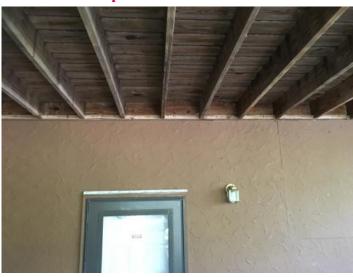
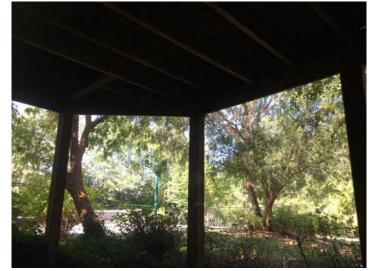
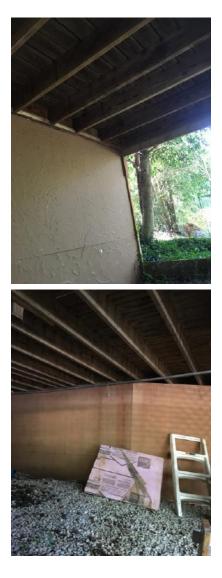
\*\*back area of pool deck\*\*

- Wood Soil Contact. Even "treated" wood is better in contact only with cement.
- Spindle spacing exceeds the 4 inch spacing which is considered safe by today's child safety standards.
- Some deck boards are damaged, and som others need resecuring.
- No Lag Bolts Visible: The deck ledger board is nailed or screwed to the house, or is covered and not
- visible. Consider installing lag screws to securely attach ledger board to house, if they have not been used.

• Rails missing in areas with drop offs of greater than 30 inches. Recommend installation of rails for safety.

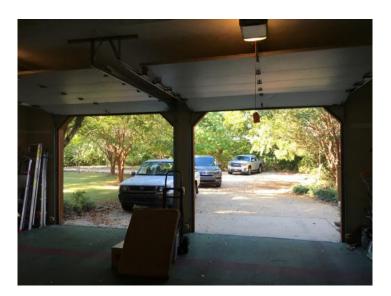
- Personal items in garage block complete inspection of all floor, wall and ceiling areas.
- Garage vehicle door panels damaged.

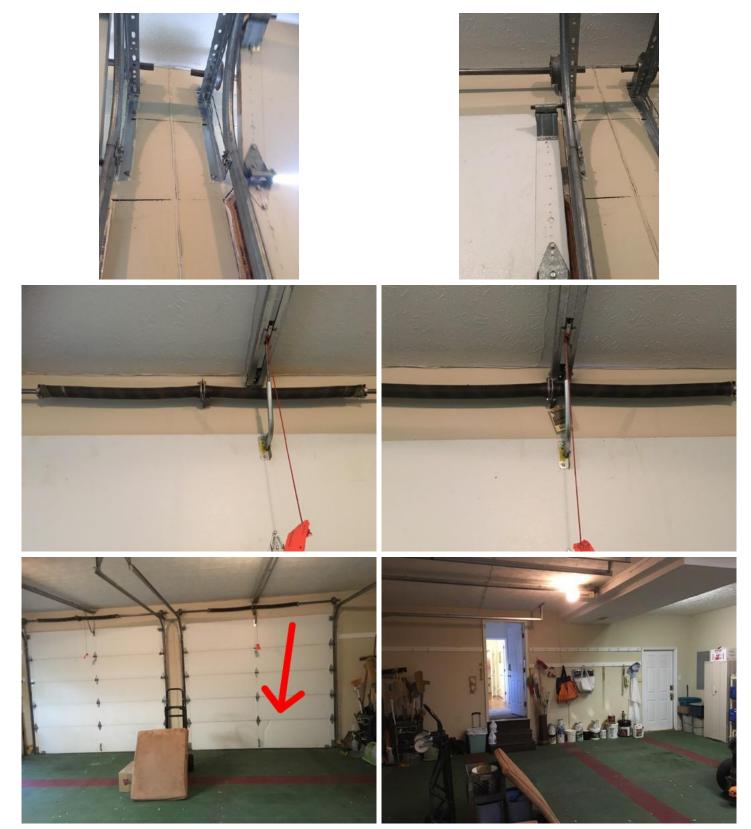
Door damage

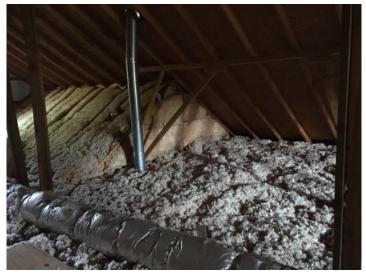
- Fiberglass Insulation
- Insulation averages about 10-12 inches in depth
- Attic partially traversed
- Electrical Box Covers missing or damaged, which is a potential shock or electrocution hazard.
- Wire ends are outside of a Junction Box, which is a potential shock or electrocution hazard.
- Cracks / hole(s) in roof sheathing, daylight visible at skylight

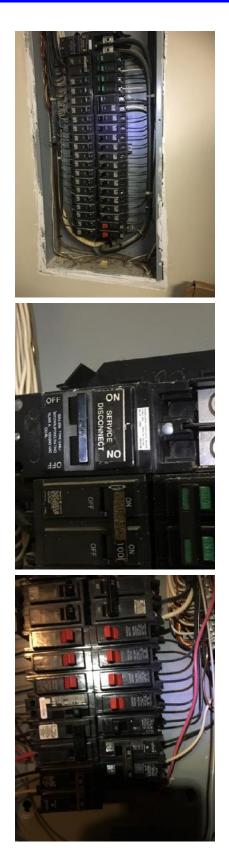
• Panel cover screw(s) missing.

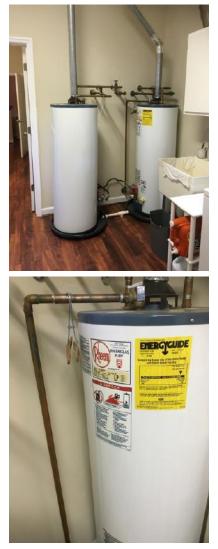
- "Sediment Knock" in tank noted; may decrease efficiency of the water heater.
  Flame roll out present on both units. Recommend a plumber to evaluate fuel supply and venting and repair as needed.

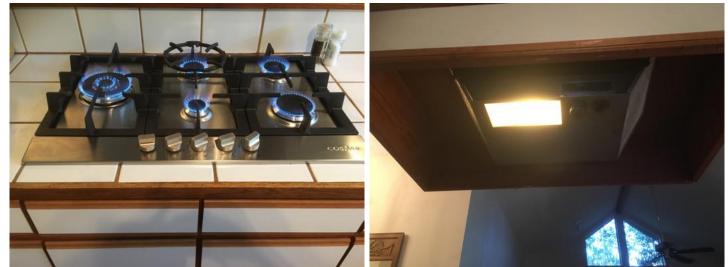
- Backsplash needs minor caulk repair. Left of refrigerator
- Range hood: Fan and light operable. Recommend cleaning vents.
- Countertop damage. Cracked time to left of refrigerator

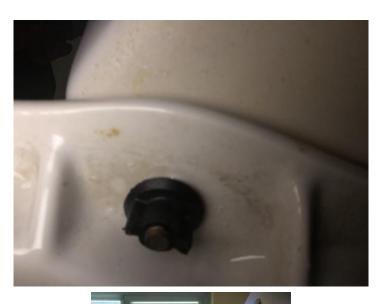
- LOCATION: between bedroom and laundry
  Shower floor junction needs caulk / grout.
  Toilet loose; recommend having re-anchored.

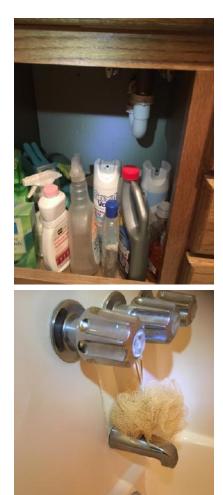
• No operable exhaust fan in bathroom with shower. Even if a window that opens exists, this may not be adequate ventilation during the cold weather. Recommend installing properly vented bathroom exhaust fan.

• Shower faucet leaks.
