Your Property Inspection Report

1234 Main Street, Unit 112, Columbus, Ga 33333

Date of Inspection: 8/6/2016 Time: 11:00 central

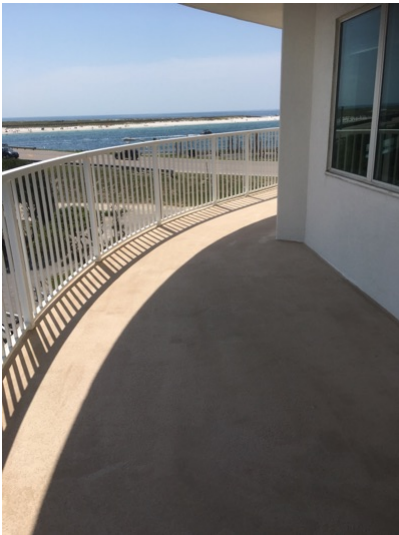
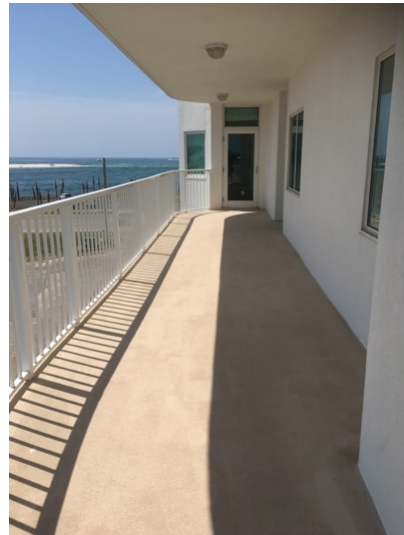
- The deck appears to be in good serviceable condition with proper grading away from the unit.
- The rails appear to be in good condition at the time of inspection.
- Paint is peeling at the exterior door from living room. Recommend touch up paint

Livingroom door paint

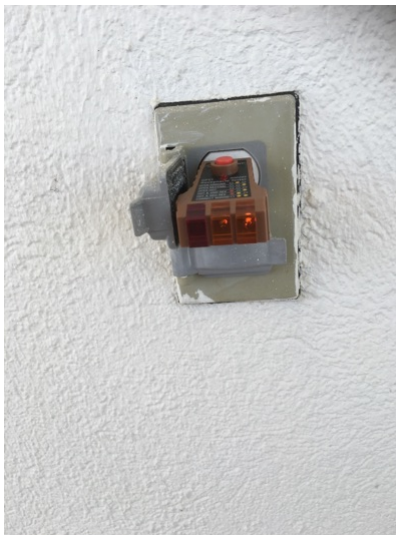
Exterior outlets operating normally

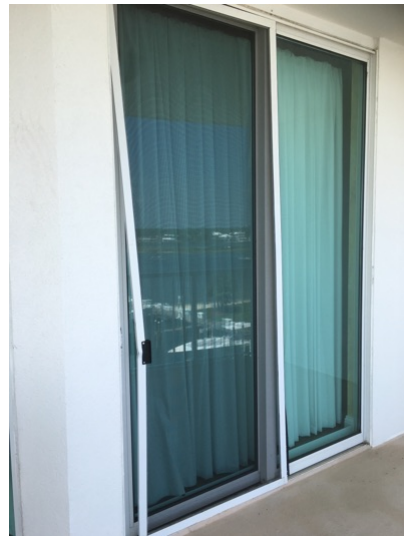
- The screens on the sliding doors to both master and living room exterior doors bind in the frame. Repair recommended.
- Screen to master bedroom sliding door is damaged. Repair or replacement recommended.

Screen binds in frame (master)

Exterior Areas		
Page 5 Item: 9	Doors	<ul style="list-style-type: none"> • The screens on the sliding doors to both master and living room exterior doors bind in the frame. Repair recommended. • Screen to master bedroom sliding door is damaged. Repair or replacement recommended.
Electric, Heat, Water Heater		
Page 10 Item: 2	HVAC Unit	<ul style="list-style-type: none"> • Electric Furnace: Last service date is over one year ago, or is unable to be determined. Although this unit appears to be operating properly from controls, there are areas which cannot be seen without specialized equipment and training. Furnace specialists recommend a complete inspection annually; consider having unit inspected by certified HVAC technician.
Interior Features		
Page 11 Item: 1	Kitchen	<ul style="list-style-type: none"> • Free standing ice maker is leaking. Have appliance repair man to repair. • Bar sink cabinet has water damage. Repair or replace.

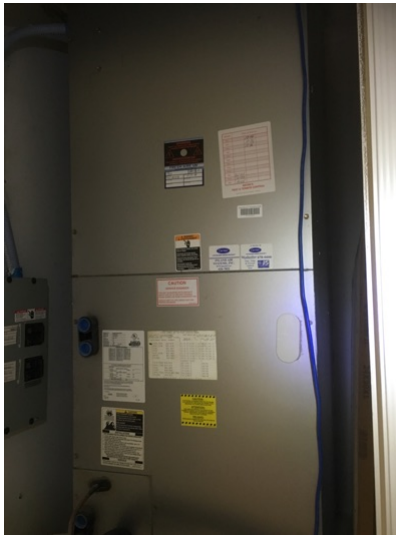
- No major system safety or function concerns noted at time of inspection.
- **Electric Furnace: Last service date is over one year ago, or is unable to be determined. Although this unit appears to be operating properly from controls, there are areas which cannot be seen without specialized equipment and training. Furnace specialists recommend a complete inspection annually; consider having unit inspected by certified HVAC technician.**

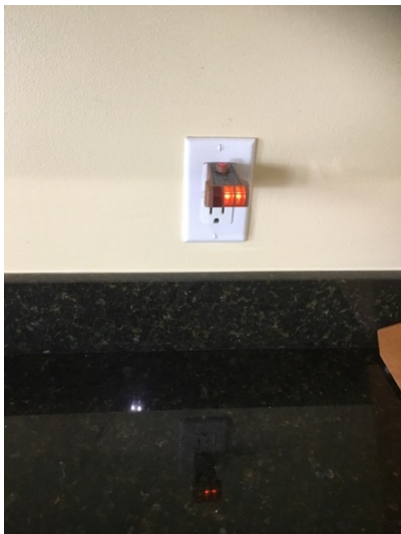
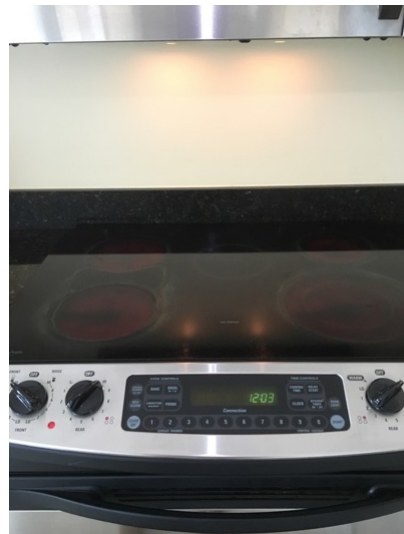
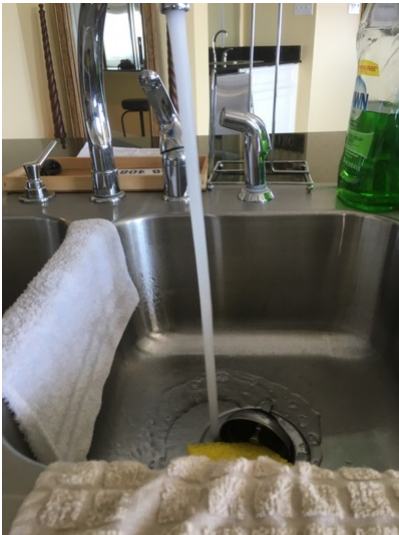
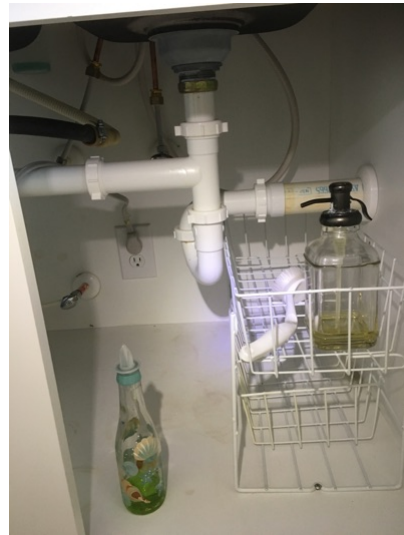
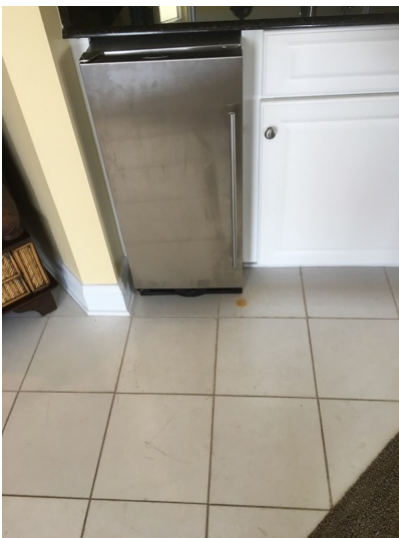
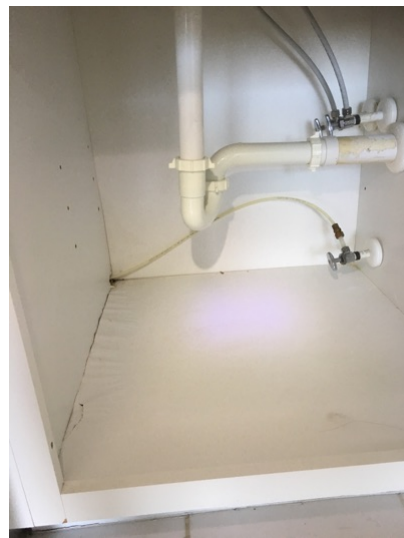
- Past leak noted under bar sink
- **Free standing ice maker is leaking. Have appliance repair man to repair.**
- **Bar sink cabinet has water damage. Repair or replace.**

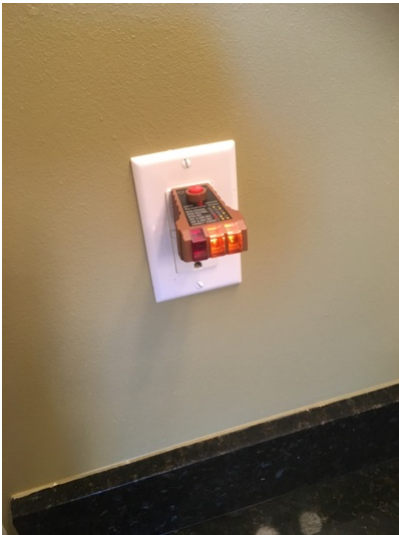
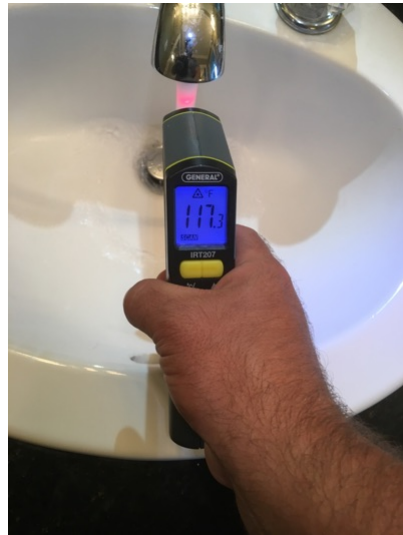
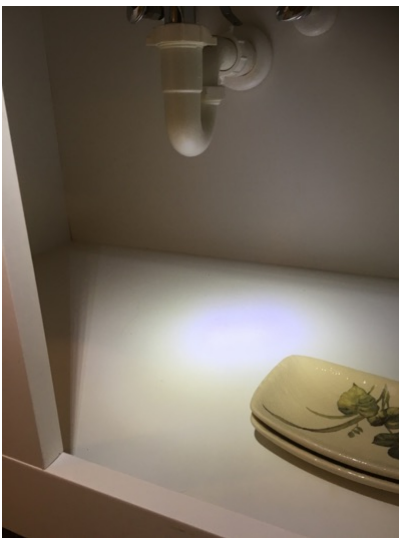
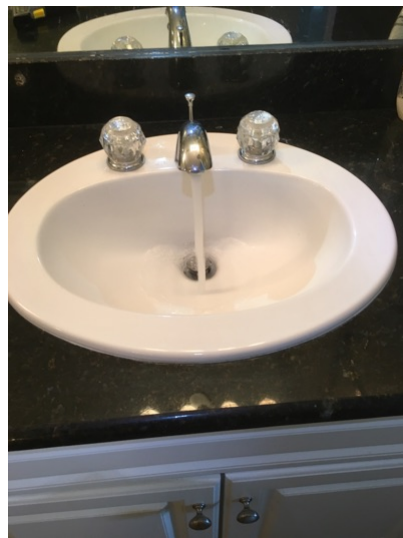
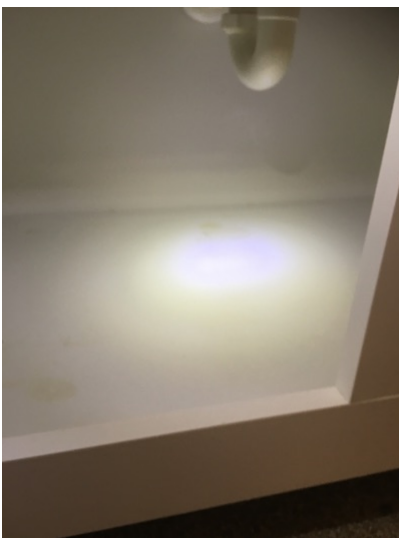
- **Shower head leaks. Recommend repair**
- **Possible organic substance on ceiling in toilet room. Recommend cleaning and painting with paint approved for damp area**

Page 13 Item: 2	Master Bath	<ul style="list-style-type: none"> • Shower head leaks. Recommend repair • Possible organic substance on ceiling in toilet room. Recommend cleaning and painting with paint approved for damp area
Page 15 Item: 4	Bath #2	<ul style="list-style-type: none"> • Shower head leaks. Repair recommended
Page 16 Item: 7	Plumbing & Laundry	<ul style="list-style-type: none"> • An organic substance may be forming on the ceiling in laundry room. Recommend cleaning with a good antibacterial cleaner (bleach) and repaint with a paint made for damp areas.
Page 17 Item: 8	Interior Electric	<ul style="list-style-type: none"> • Smoke detector in living room and hall way may be beyond serviceable life. Smoke detectors should be replaced every 10 years. The yellowing of the case indicates age.
Page 19 Item: 10	Doors	<ul style="list-style-type: none"> • Closet doors in bedroom 1,2,&3 are off track. Repair is needed

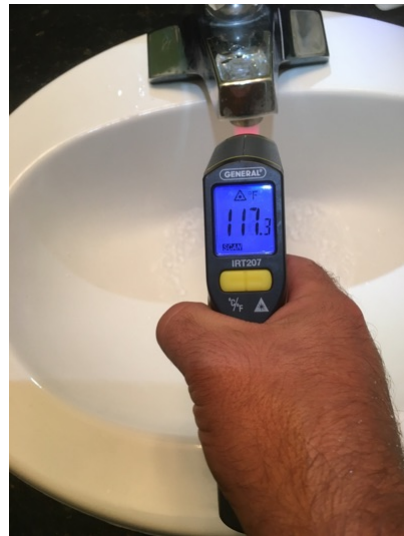
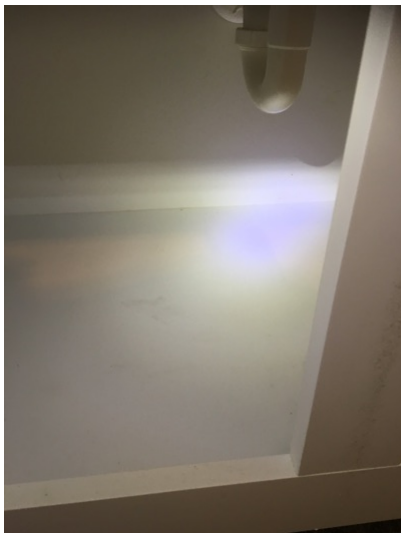
- LOCATION: at bedroom 3
- Recommend tub/wall junction be recaulked
- **Shower head leaks. Repair recommended**

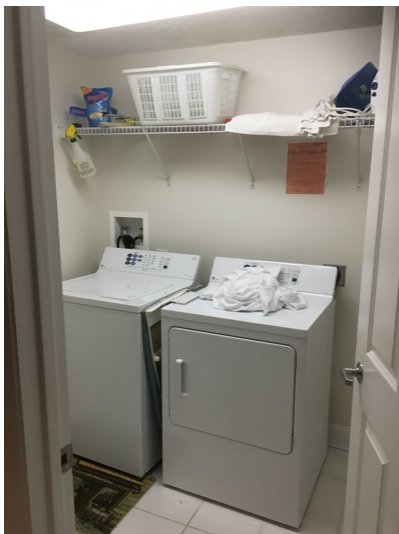
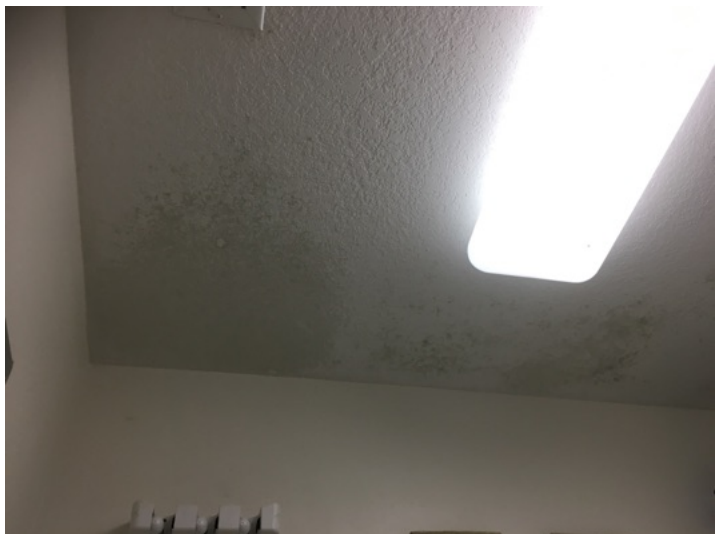
- No major system safety or function concerns noted at time of inspection.
- Dryer vent pipe damaged. Replacement recommended
- **An organic substance may be forming on the ceiling in laundry room. Recommend cleaning with a good antibacterial cleaner (bleach) and repaint with a paint made for damp areas.**

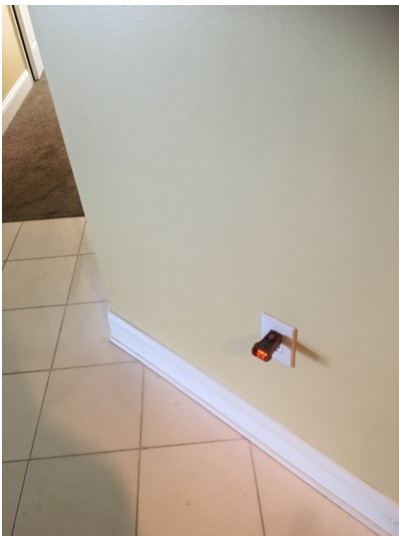
Entry

- All accessible outlets were tested and appear to be functional at the time of inspection. All GFCI outlets responded appropriately to the test. Testing is performed with a device inserted into the outlet. The two amber lights shown in the photos indicate proper function.
- **Smoke detector in living room and hall way may be beyond serviceable life. Smoke detectors should be replaced every 10 years. The yellowing of the case indicates age.**

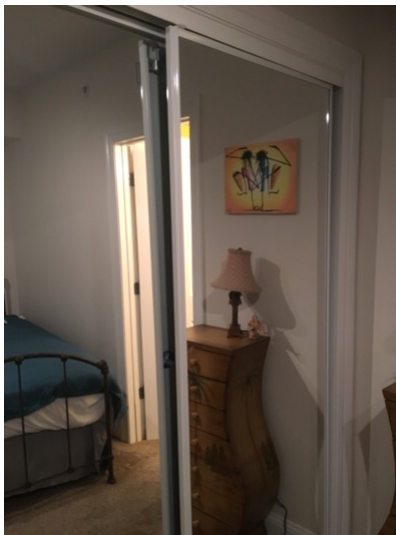
Bedroom 1

- Door between bedroom 2 and its bathroom catches in frame. Repair recommended. Likely only sanding and trim will be sufficient
- **Closet doors in bedroom 1,2,&3 are off track. Repair is needed**
