# Caleb Kinsaul Real Estate Services LLC. Your Property Inspection Report

2222 A Street, Columbus, GA 22222 Inspection prepared for: Sample Sample Real Estate Agent: Support - Home Inspector Pro

Date of Inspection: 9/6/2016 Time: 9:00 AM Age of Home: 24 Size: 3200 Weather: Clear SAMPLE

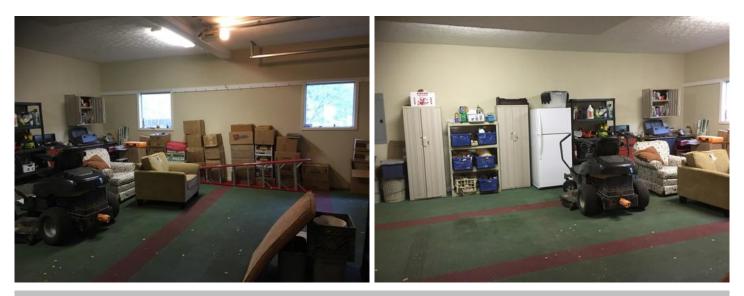
Door damage

- Personal items in garage block complete inspection of all floor, wall and ceiling areas.
- Garage vehicle door panels damaged.

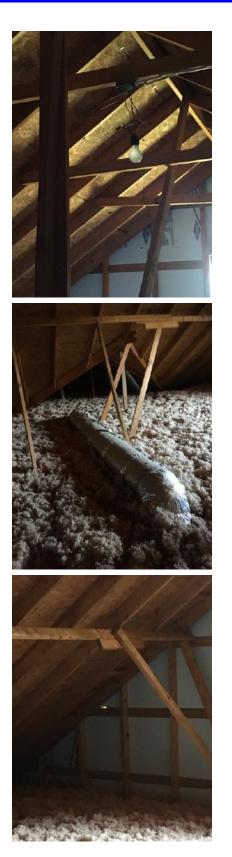
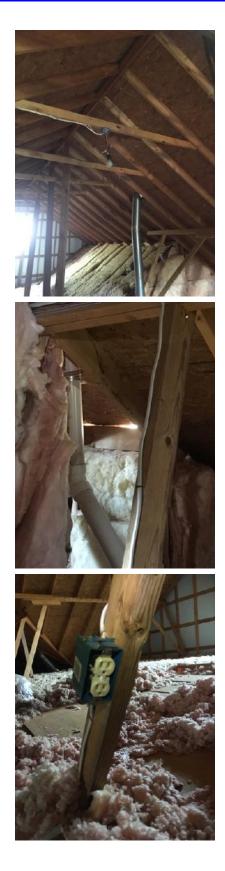
- Fiberglass Insulation
- Insulation averages about 10-12 inches in depth
- Attic partially traversed
- Electrical Box Covers missing or damaged, which is a potential shock or electrocution hazard.
- Wire ends are outside of a Junction Box, which is a potential shock or electrocution hazard.
- Cracks / hole(s) in roof sheathing, daylight visible at skylight

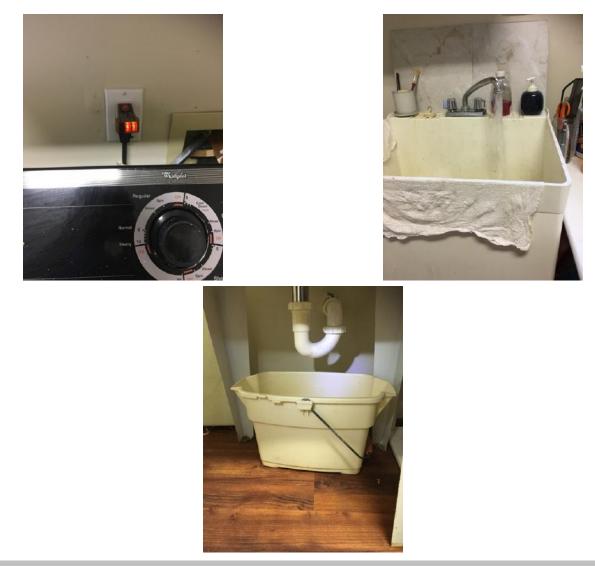
Observations: • Laundry sink not well secured. Recommend securing sink to avoid tip over or damage to pmumbing
